DEPARTMENT OF TRANSPORTATION

Quality Assurance and Source Inspection

Contract #: 04-0120F4Cty: SF/ALA Rte: 80 PM: 13.2/13.9File #: 69.28**WELDING INSPECTION REPORT****Resident Engineer:**Siegenthaler, Peter**Address:** 333 Burma Road**City:** Oakland, CA 94607**Report No:** WIR-018977**Date Inspected:** 24-Dec-2010**Project Name:** SAS Superstructure**OSM Arrival Time:** 700**Prime Contractor:** American Bridge/Fluor Enterprises, a JV**OSM Departure Time:** 1900**Contractor:** Zhenhua Port Machinery Company, Ltd (ZPMC), Changxing Island **Location:** Shanghai, China

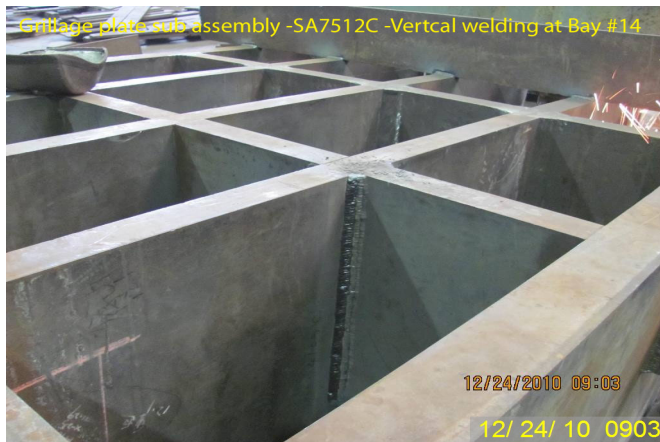
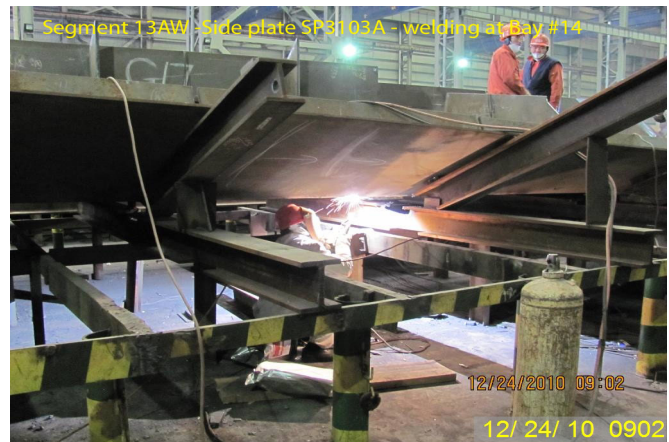
For further information see below pictures:-

Unless otherwise noted, all work observed on this date appeared to be in general compliance with the applicable contract documents.
